**Quality Petroleum Equipment  
Solutions for Over 25 Years**

**VMI-3300 & VMI-3300\FL  
3" In-line Check Valves**

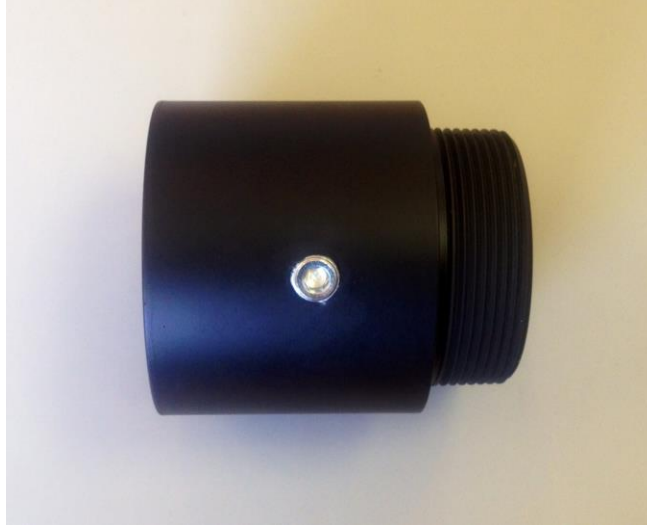
**VMI-3300 In-line Check Valve, 15 PSI Relief  
3" Male NPT Inlet, 3" Female NPT Outlet**

**VMI-3300\FL In-line Check Valve, 15 PSI Relief  
3" Male NPT Inlet, Flanged Outlet**

The VMI-3300 installs in the discharge of the STP, providing a very economical solution and an easy to access, replaceable pressure relief.
